Sustainable Rehab: *Simple to Complex Fixes of Existing Buildings*

GreenHomeNYC October Forum

12 Buildings in 30 minutes:

Multifamily Audits & Rehabs:
Small, medium, large;
oil, gas, electric;
master and individually
metered;
NYC to Buffalo;
4800 to 7000 HDD!

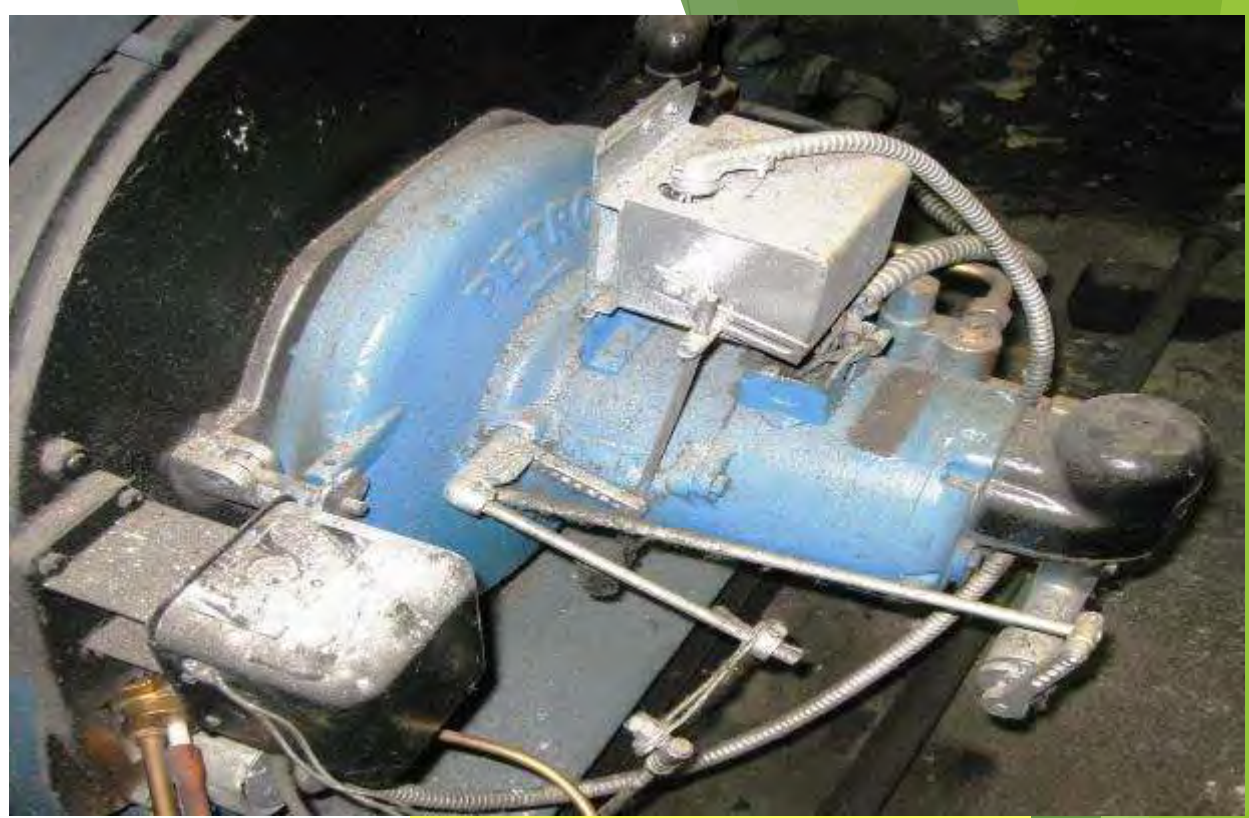
35 apts, 36,000 ft²

- Mod rehab + full weatherization package (\$4000/apt)
- Boiler, airsealing, windows, insulation, better controls
- Oil usage declined (weather adjusted) 63.7%.
- Annual oil usage from \$119,636 to \$43,448
- Savings of \$76,188 **(\$2177/apartment)** per year.

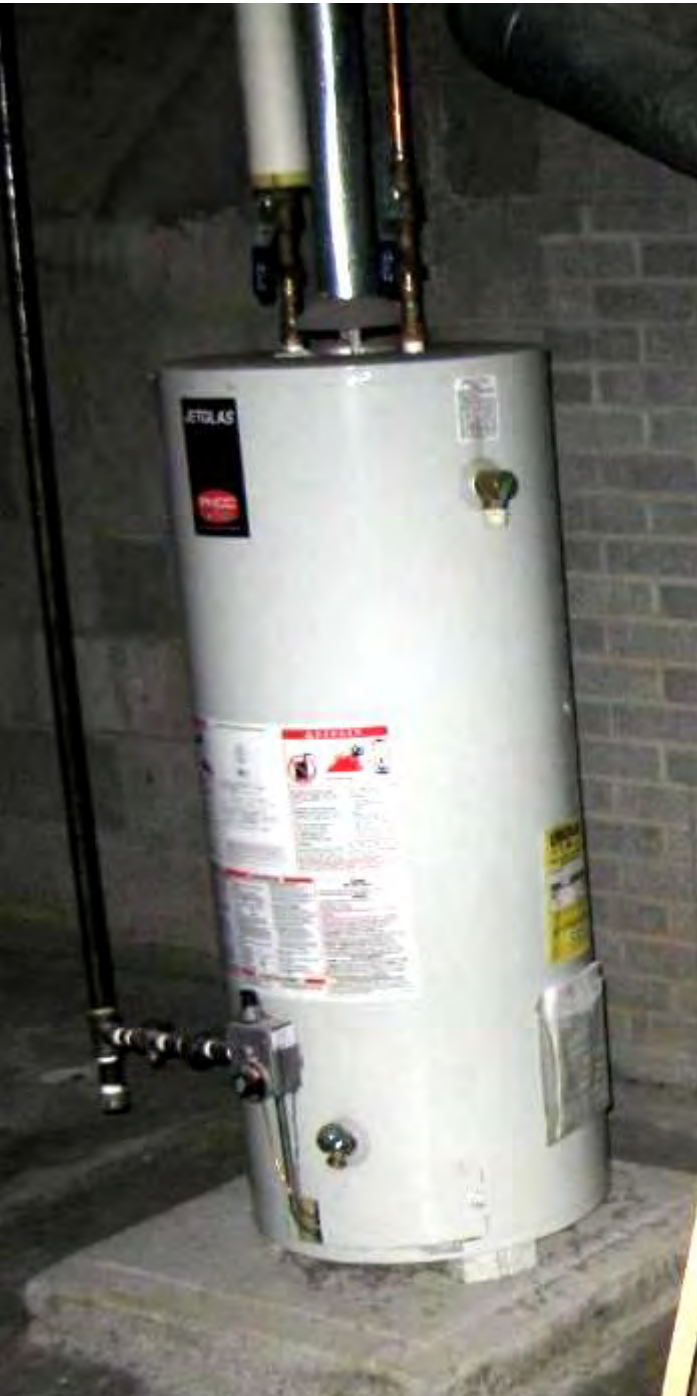
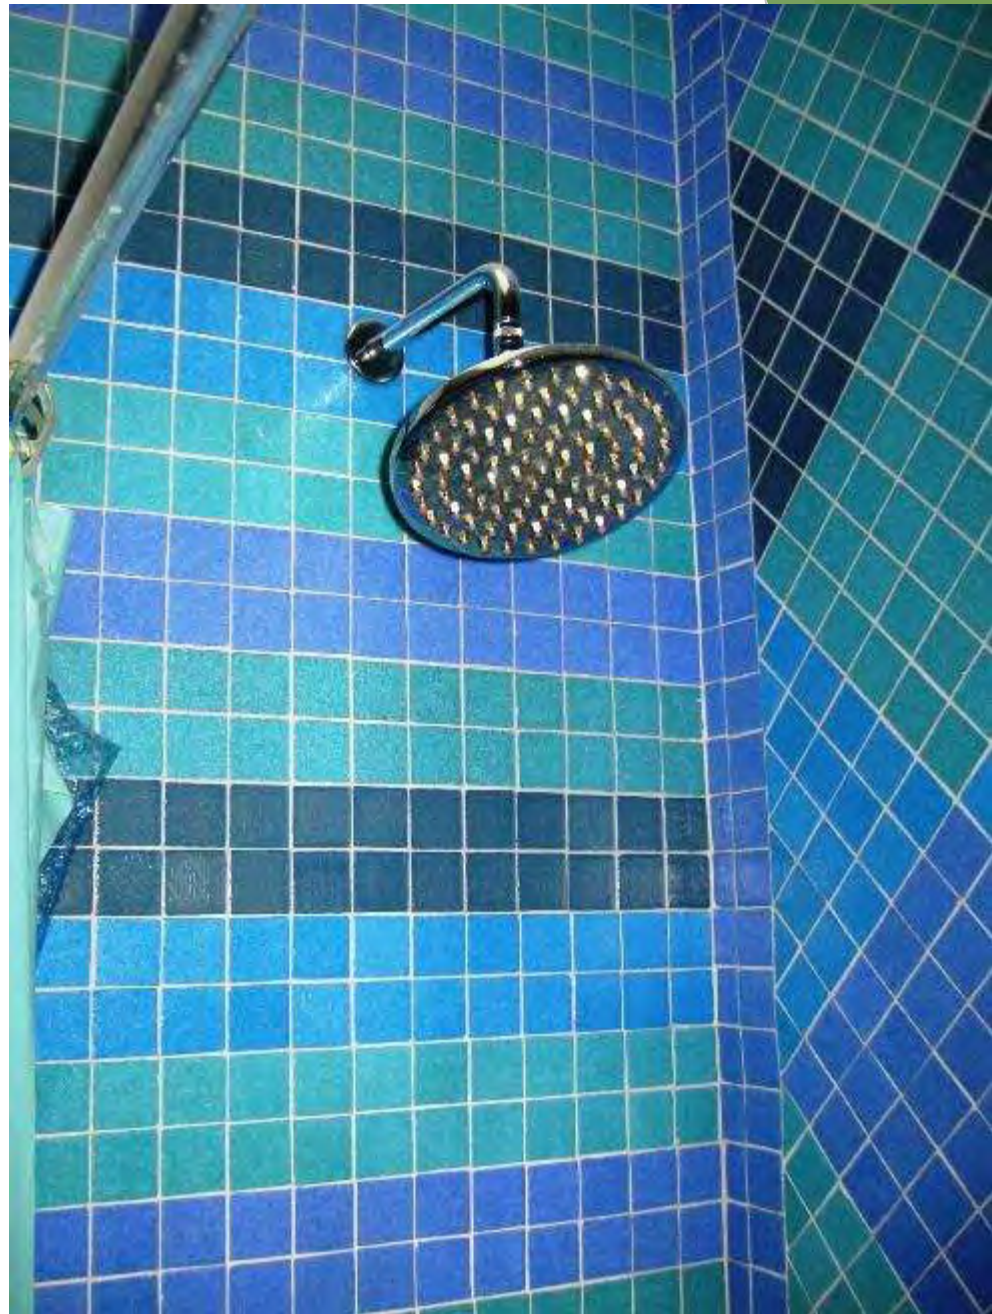
22.3%
Of gas
Usage
For
Hot
water

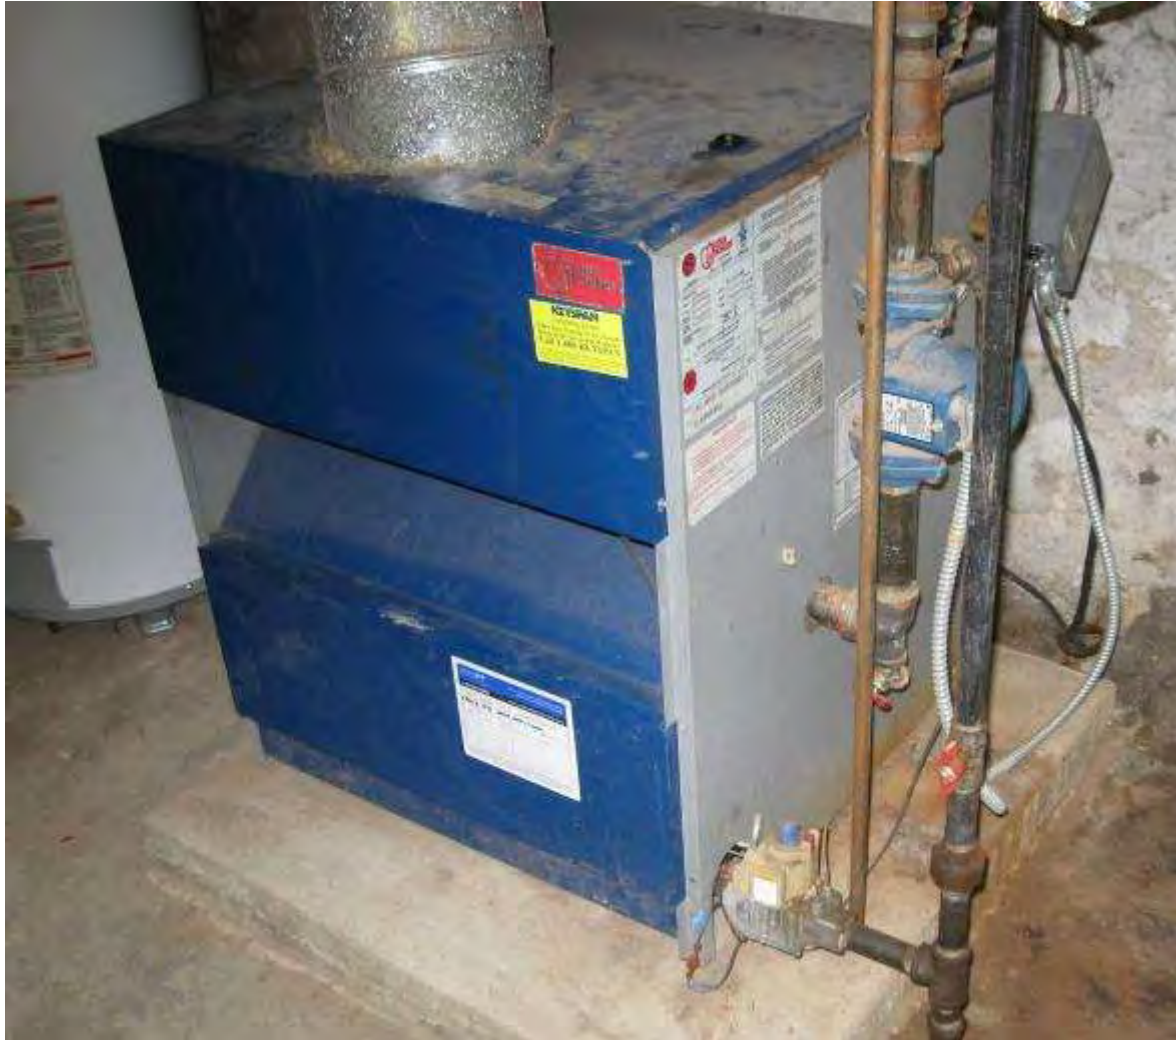
Guess the efficiency of this unit!

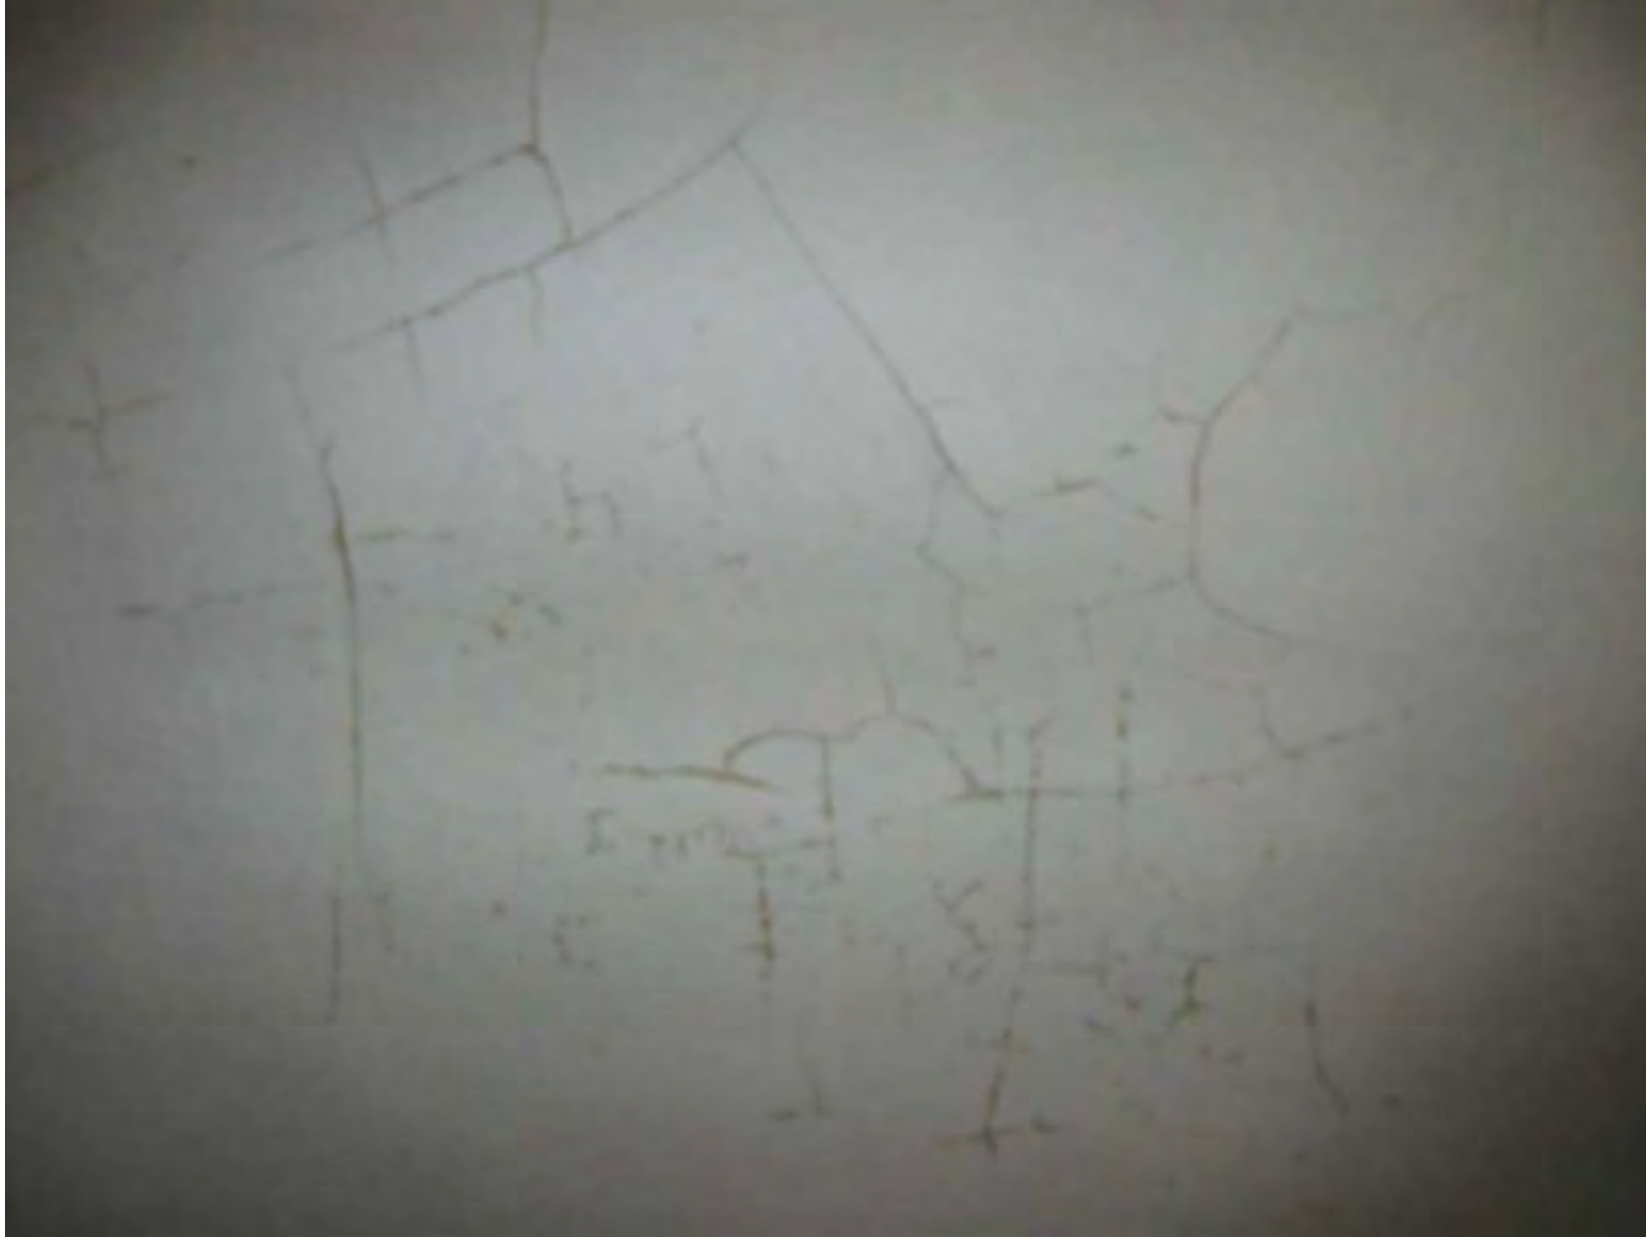
This is why I got the call...

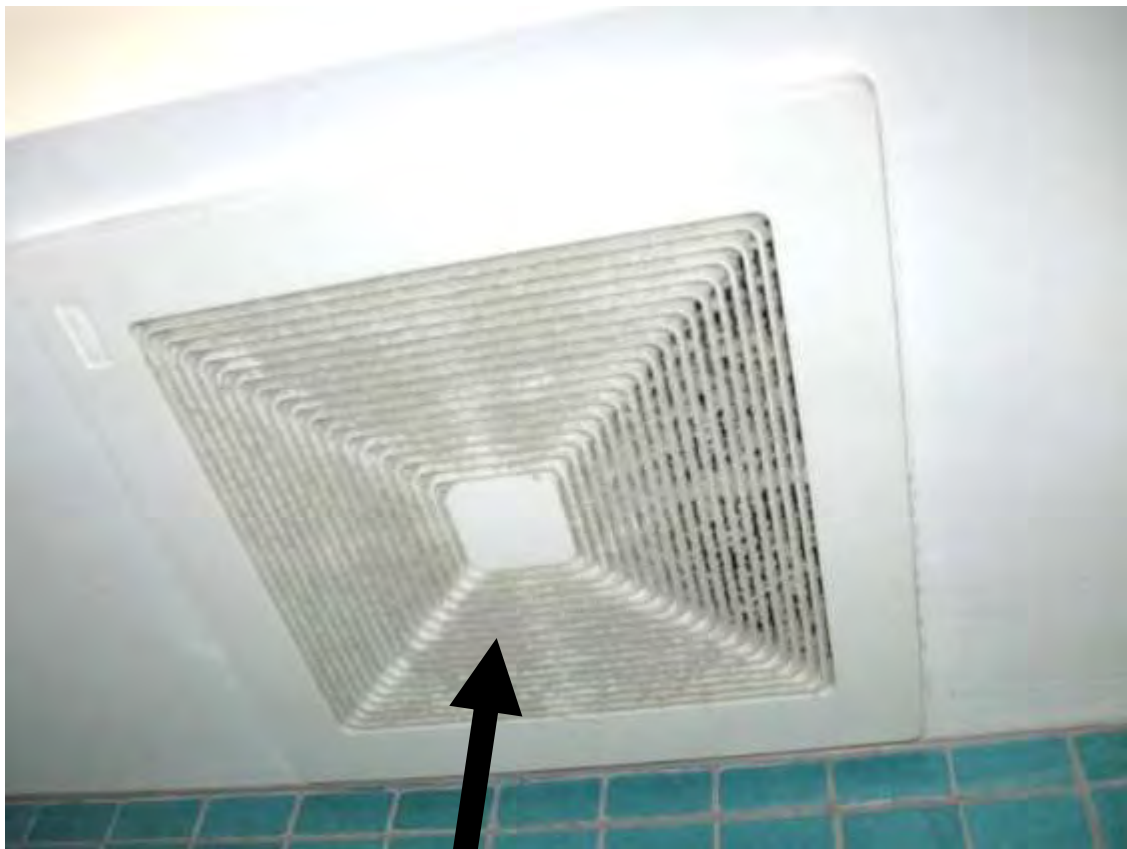
Previous owner
installed roofing
humidification &
heating system

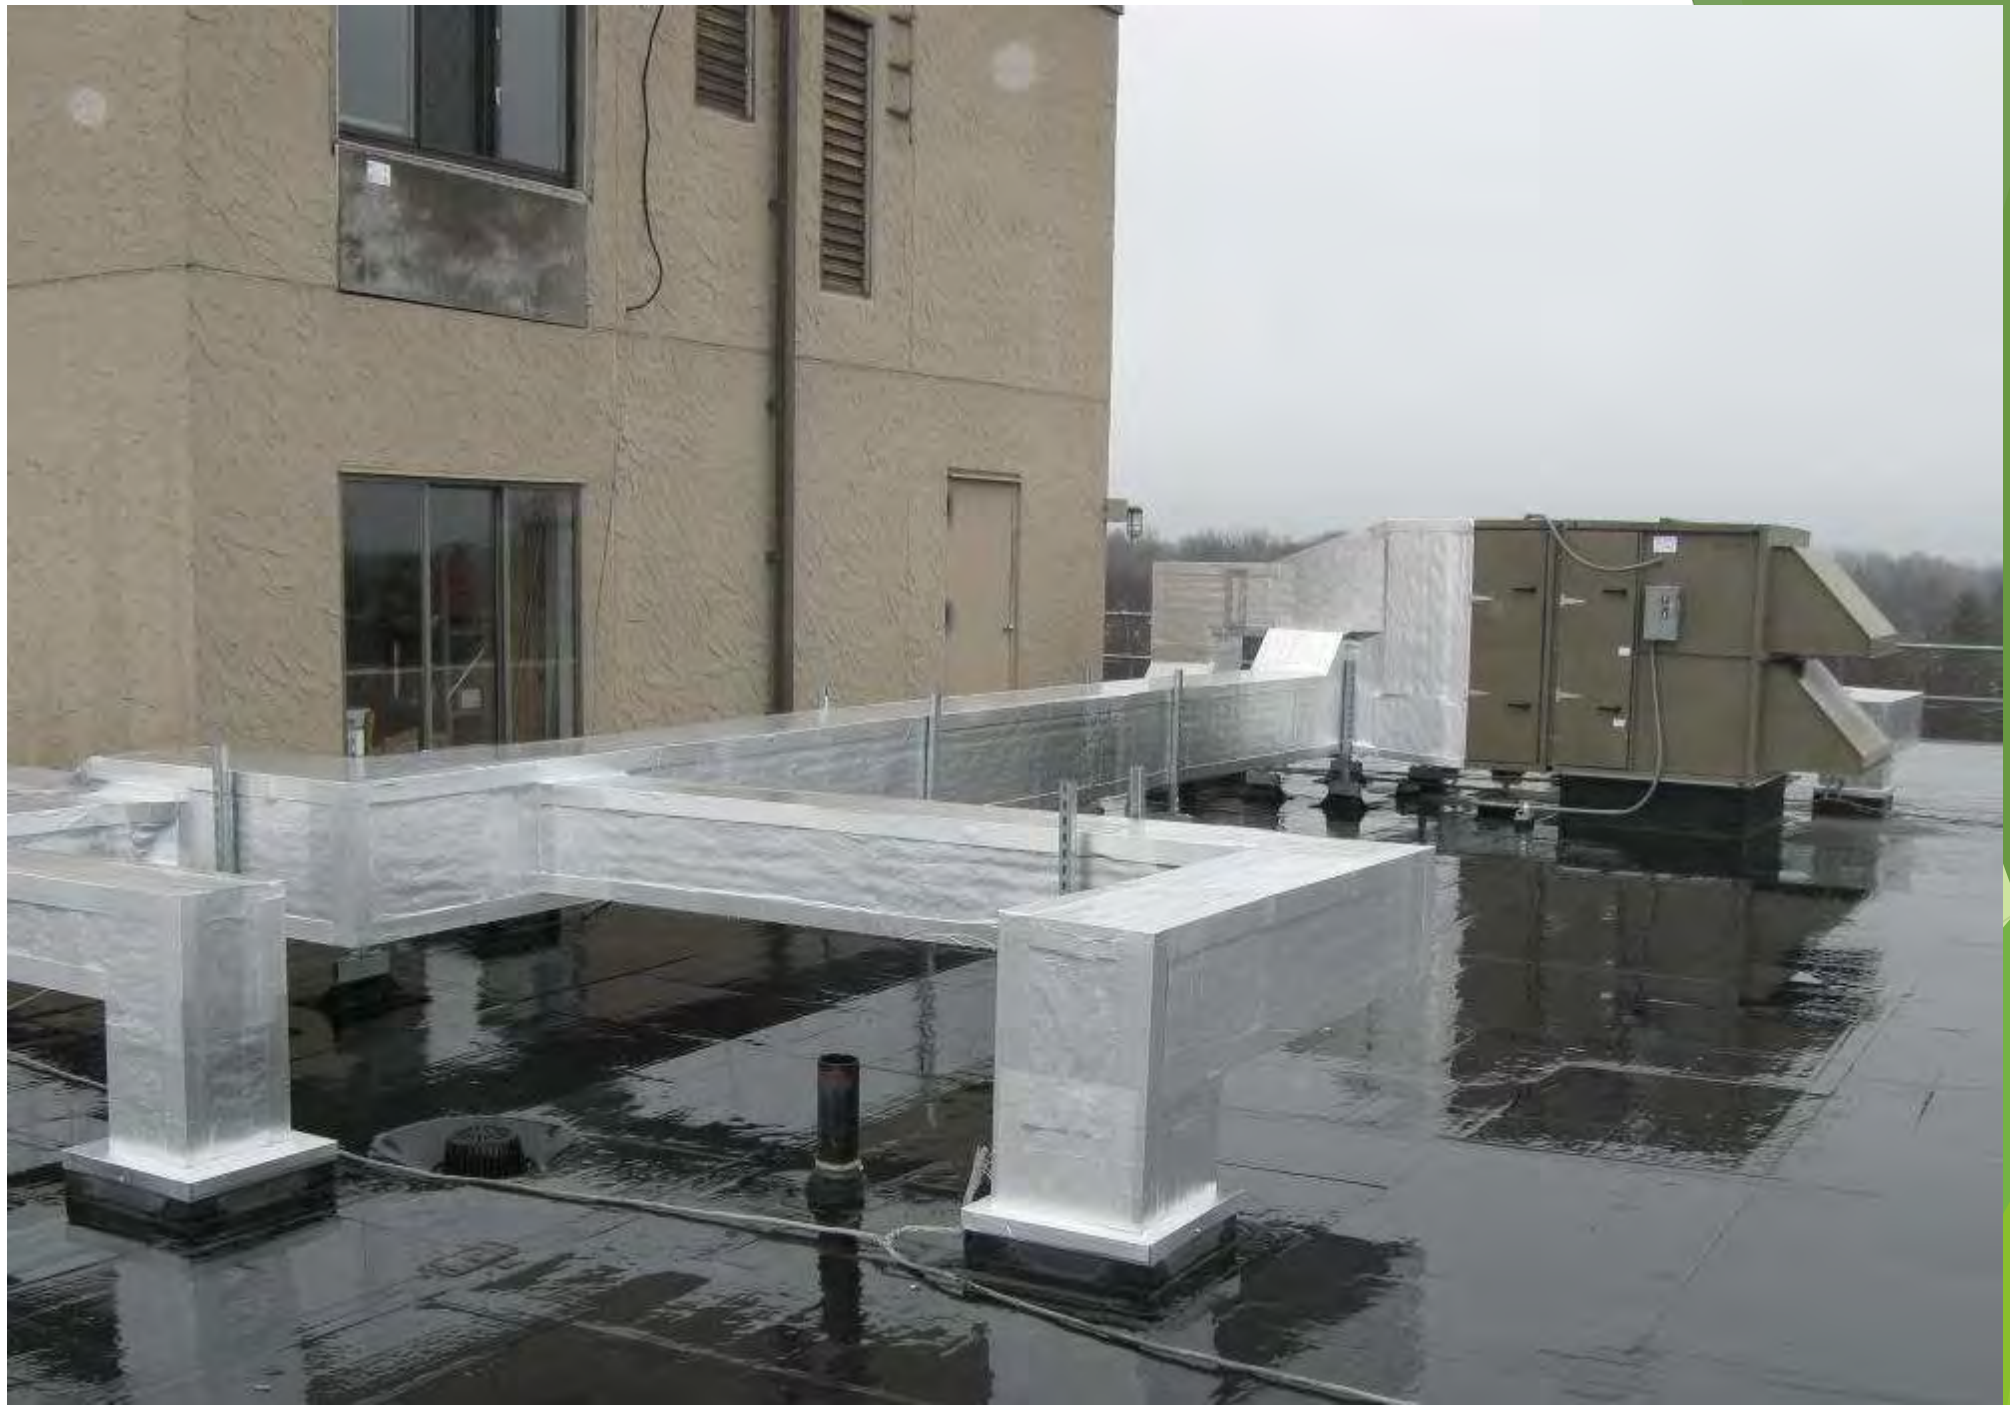
This all electric building in Auburn NY added an insulated exterior skin and windows prior to our audit; we still found cost effective work by balancing the ventilation system, adding a HRV, and doing apartment electric measures.

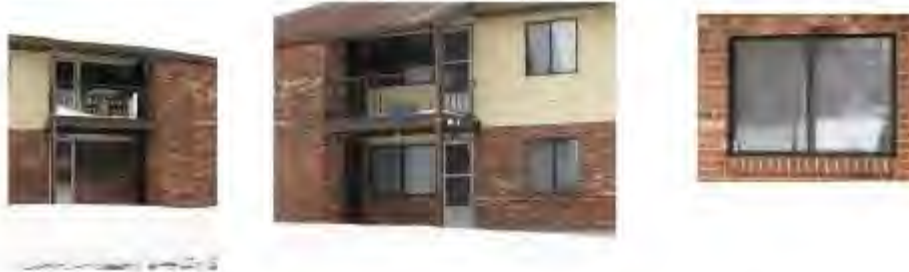
All of the windows are the original aluminum frame that are not thermally broken, and as such, act like single pane windows. The energy model calls for them to be replaced with models that have a minimum R value of 4. Some of the larger windows are less cost effective, so the owner will have to contribute depending upon the final bid price.

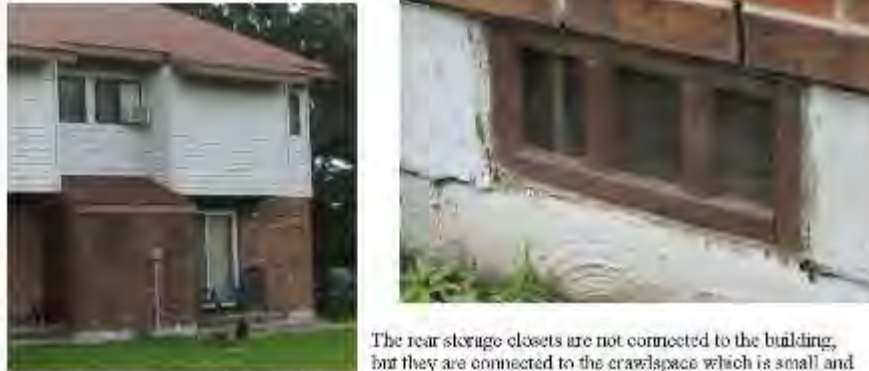
Further, the front, rear, and sliding glass doors are in poor condition, and it is cost effective to weatherstrip them. The owner wishes to replace them, and can if they pay for the majority of the cost and CPC's weatherization program invest the maximum allowed for the cost effectiveness of the weatherstripping, which would only last a few years anyway. Replacement is the better choice, but the owner must be willing to invest.

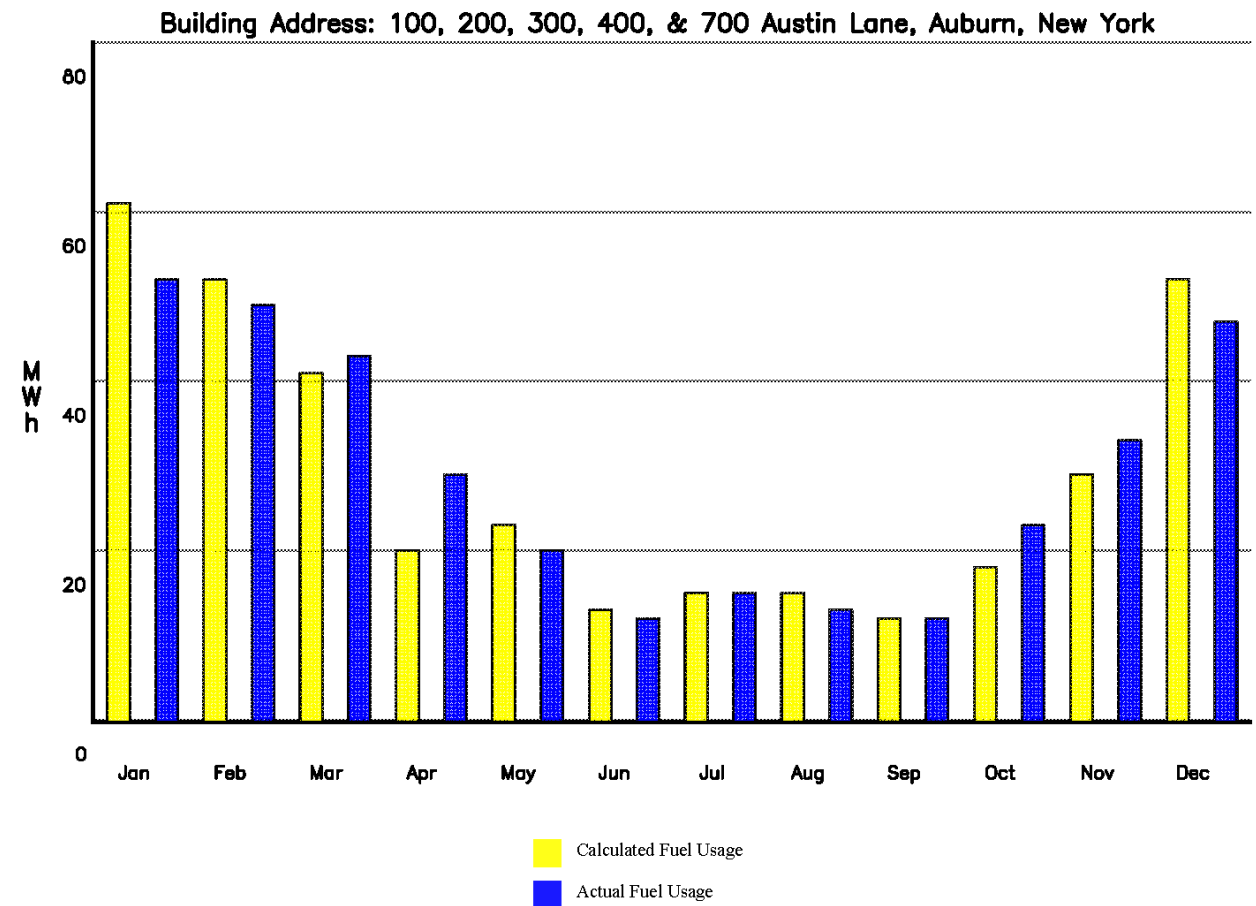
Month	Calculated Fuel Use	Actual Fuel Use	DayTime Heat On-Time	NightTime Heat On-Time	Total Heating Load	Solar Gain	Infiltration	NH Electric **
	MWh	MWh	%	%	MMBtu			
January	61.00	53.00	35.60	10.60	164.00			
February	53.00	49.00	34.60	12.00	150.00			
March	42.00	43.00	24.60	3.20	99.00			
April	20.00	30.00	8.40	0.00	29.00			
May	23.00	20.00	0.00	0.00	-1.00			
June	14.00	13.00	0.00	0.00	-3.00			
July	16.00	15.00	0.00	0.00	-5.00			
August	15.00	14.00	0.00	0.00	-3.00			
September	12.00	12.00	0.00	0.00	-1.00			
October	19.00	24.00	5.70	0.00	20.00			
November	30.00	34.00	18.20	0.00	63.00			
December	52.00	47.00	31.30	6.40	134.00			
Sum	357.00	354.00			646.00			
Average	29.75	29.50	13.20	2.68	53.00

(**) NH Electric (Non-Heating Electric Use): includes EAEM (EA-Quip Applicable Electric Measures), cooling

Attached to this description are the modeled energy usage for the all electric buildings, then an additional model with the air leakage in the building reduced by 10%. The savings from that reduction is noted on the scope of work page, and estimated savings is calculated using the incremental cost of reduced electricity at 15¢/kilowatt hour (kwh).

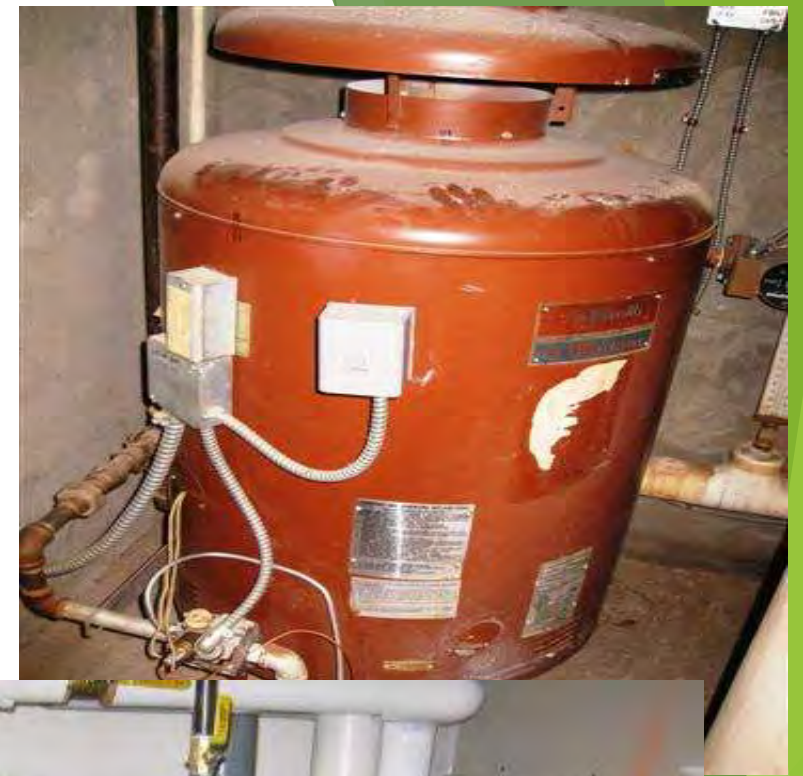
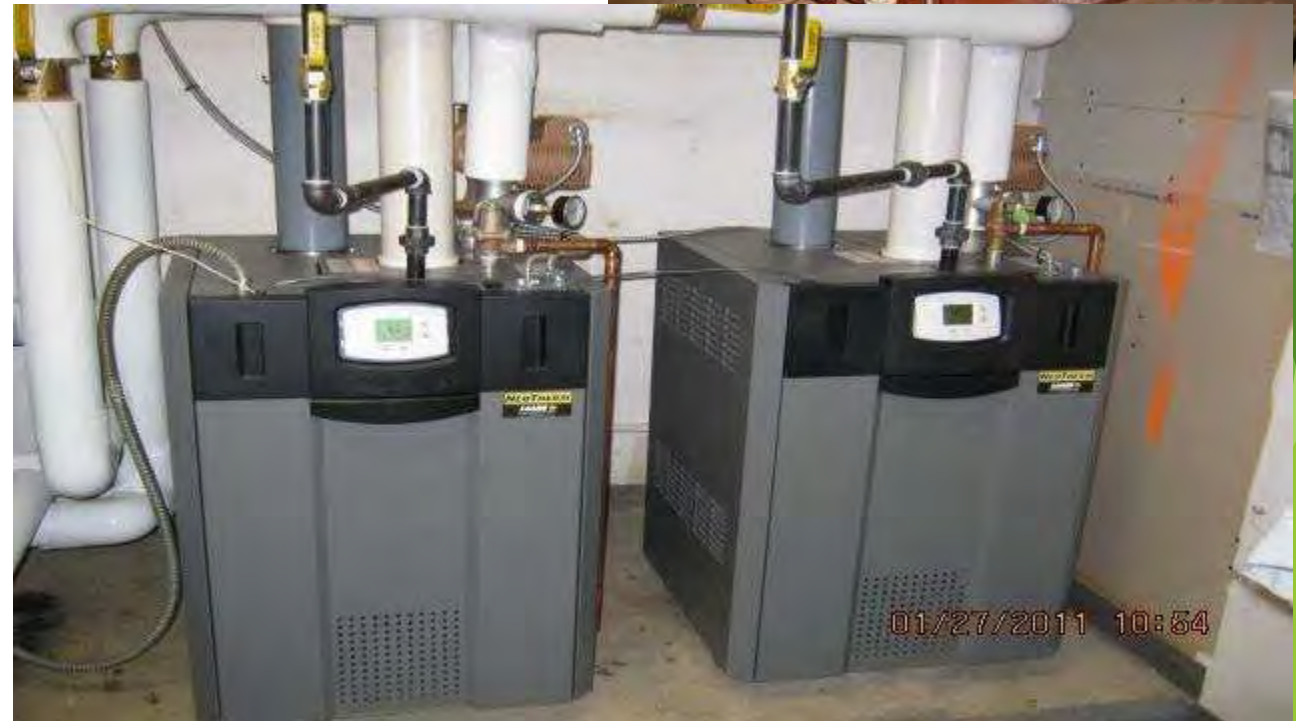
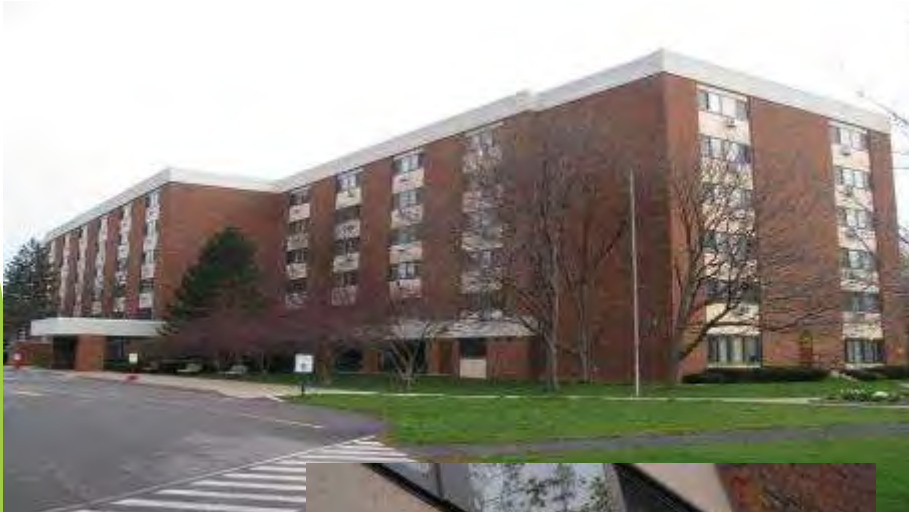
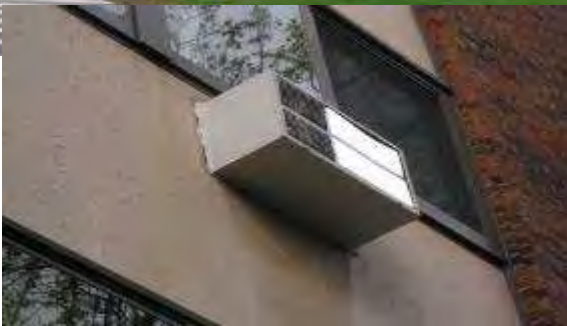
131 apartments, electric heated, individually metered
New Hot Water Makers, showerheads, aerators
Tightened apartments average 24%
Apartment electric savings 25%!
Gas use for hot water down 46%
Water use down 21%
North Street Apartments Canandagua, NY

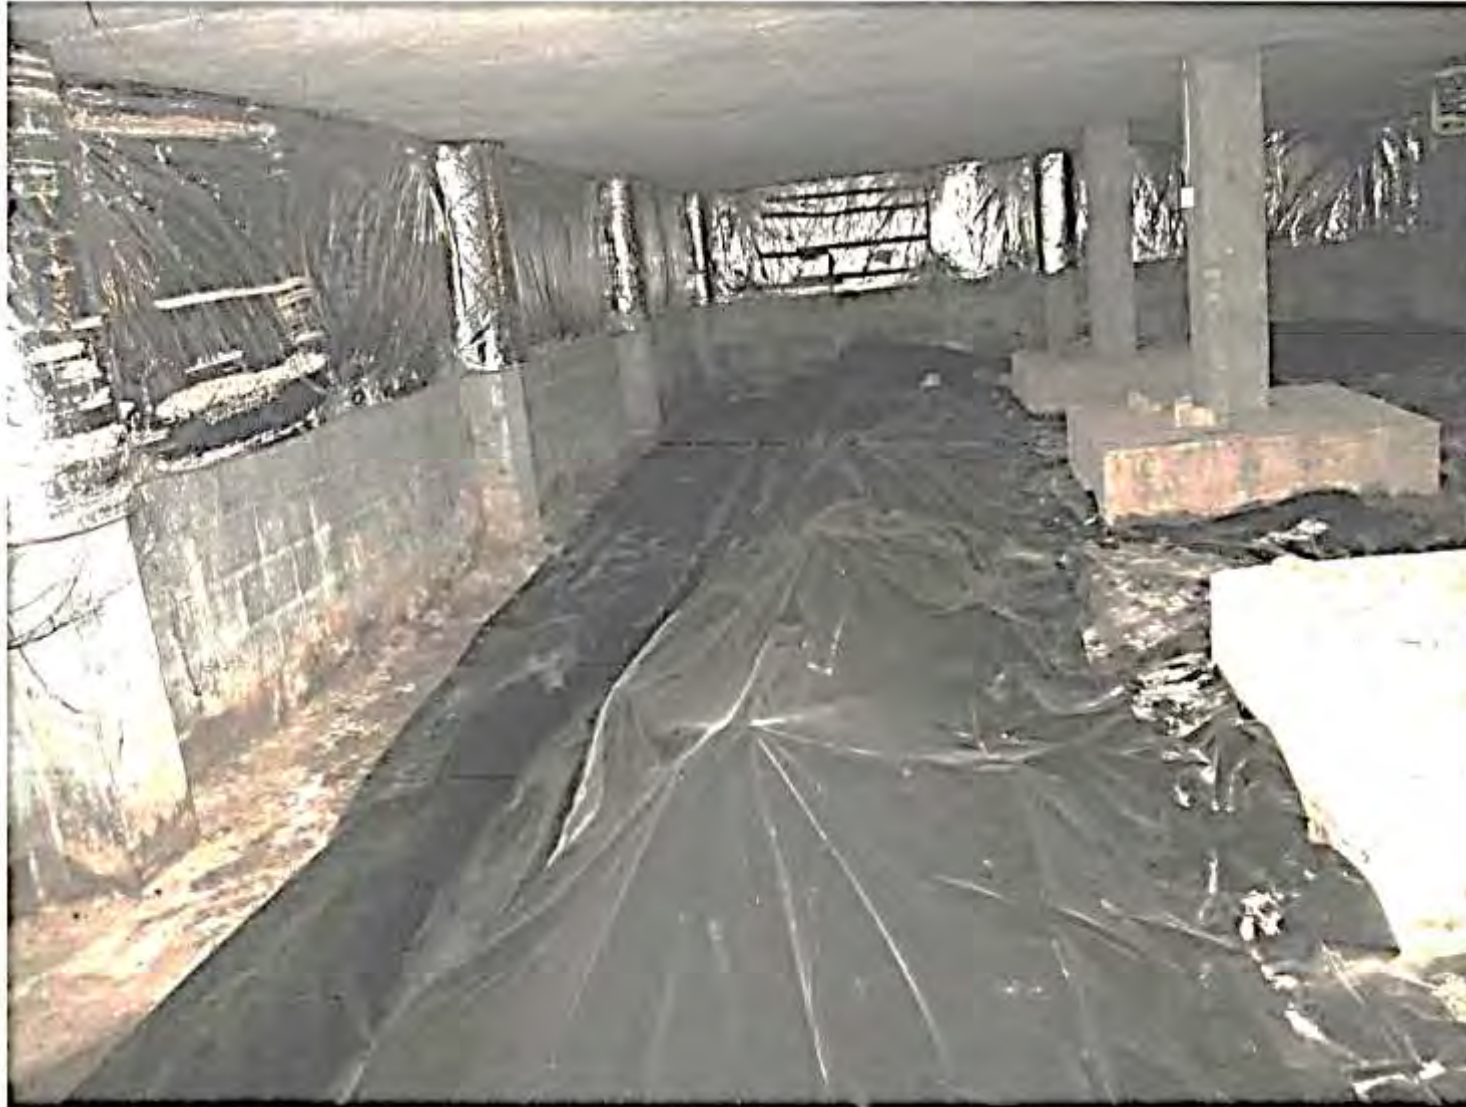
Figure 3 Typical condition at the south wall of the basement – CMU wall; top four feet covered by fiberglass roll insulation; damp footing and lower course; the earthen floor partially covered by black plastic membrane (est. 70% coverage); trench dug near the footing in an effort to direct seepage to sump crocks; concrete interior posts support the concrete floor above.

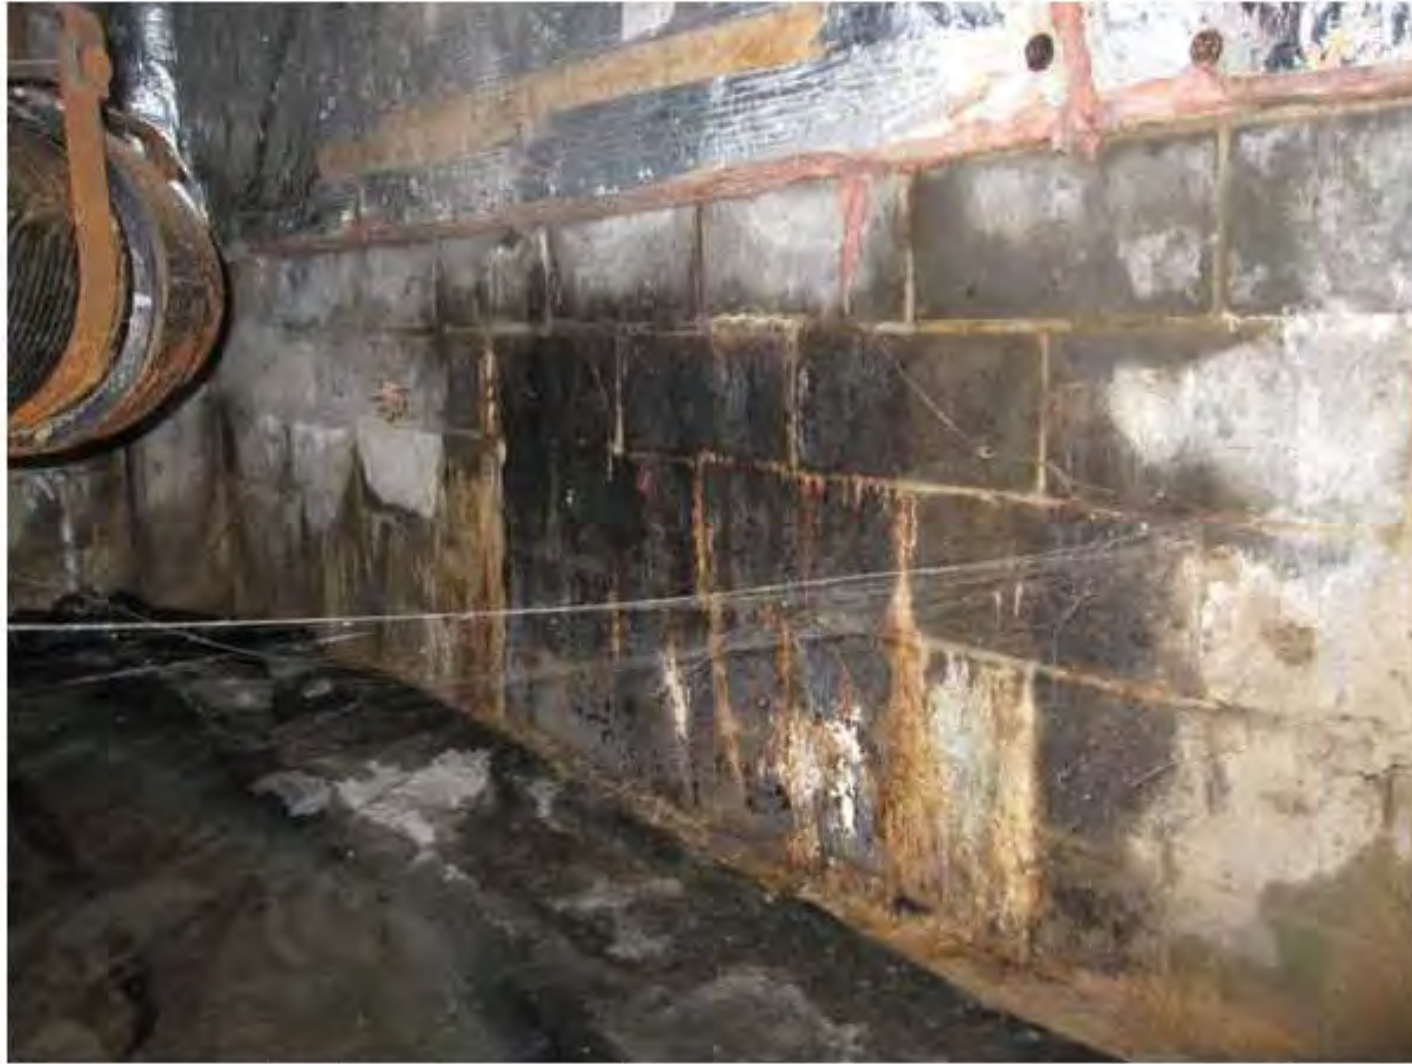
Figure 6 in the NW corner solution deposits have accumulated where rainwater runs down walls from above.

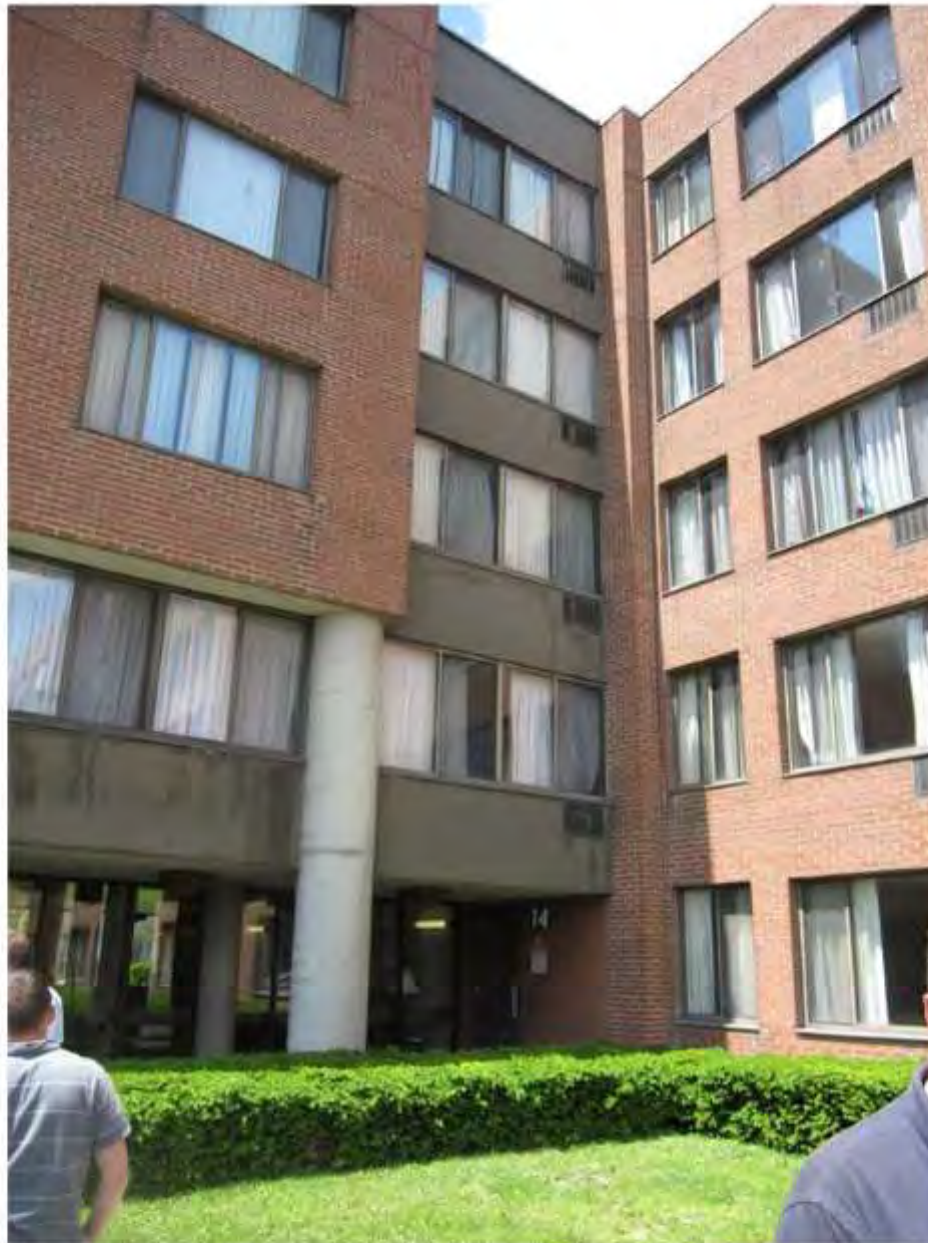
Figure 27 At the East facing entryway the detail is the same and a great deal of water enters here as well.

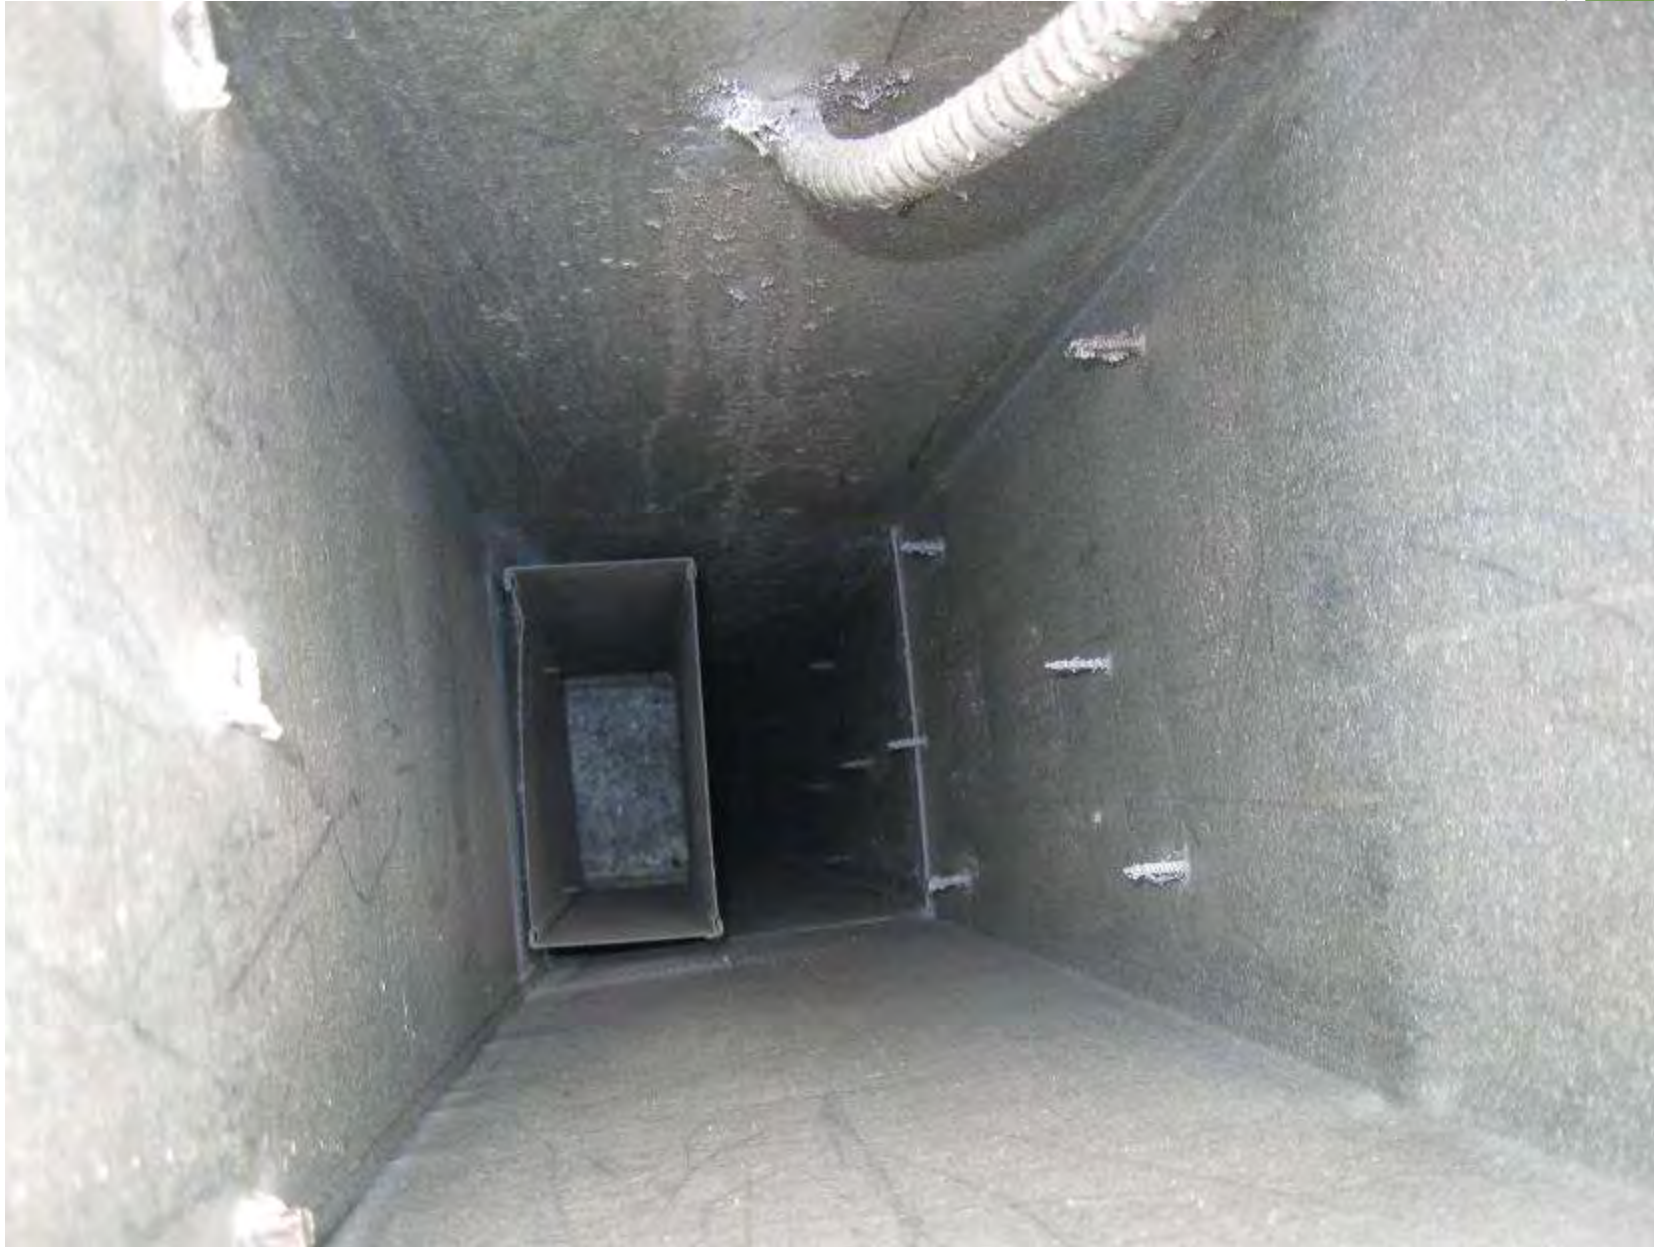
Before we fixed the basement, these roof fans operated as a building-wide moisture mitigation system
